SCHOOL DISTRICT No. 68  
Nanaimo-Ladysmith  
**RUTHERFORD ELEMENTARY SCHOOL**  
**BUILDING CONDITION ASSESSMENT**

September 2016

# RUTHERFORD ELEMENTARY SCHOOL BUILDING CONDITION ASSESSMENT

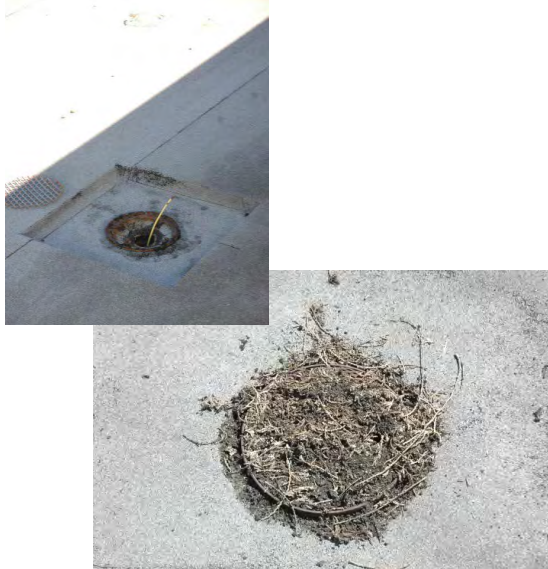
Several roof drains are missing strainers and strainers when present are flat and therefore prone to getting plugged with roof debris. Some roof drains are badly rusted, as shown in the photo far left.

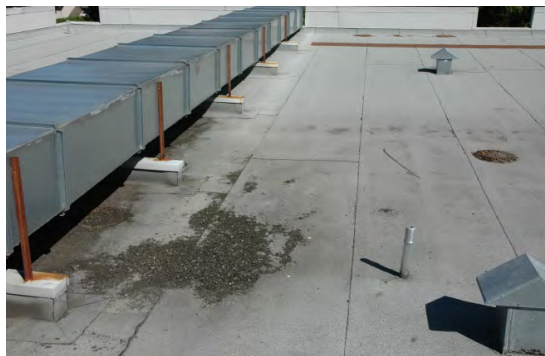
Some areas of the roof show signs of ponding. The 1981 roof is shown left.

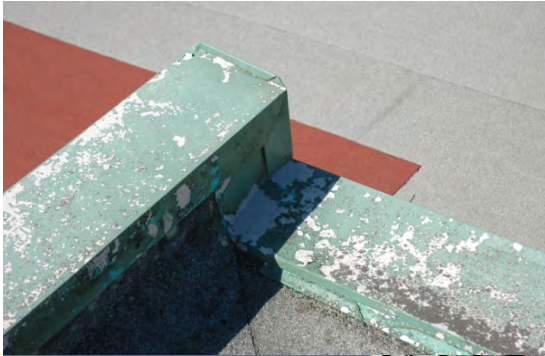
Low curb height is non-compliant with RCABC standards. Cap flashing finish is deteriorated in some locations.

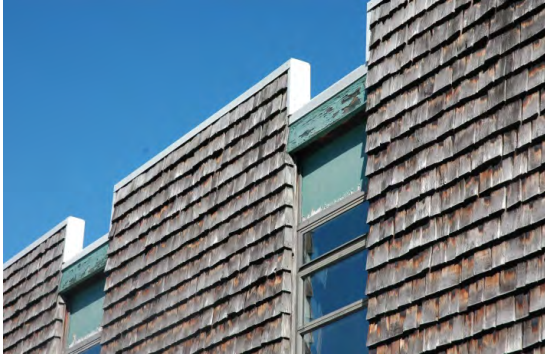
Wood fascia on 1981 block is peeling and showing signs of decay.

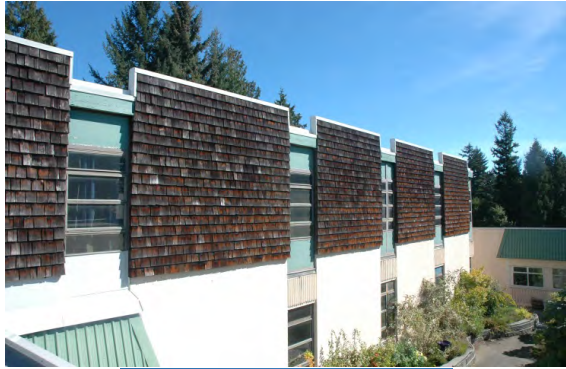
Second storey addition built in 1981 has wood shake and plywood cladding. Wood shake cladding is prone to wasp nesting.

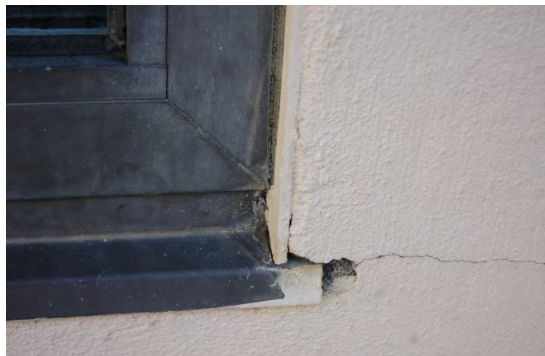
Stucco cracking and crumbling around window sill in 1998 block

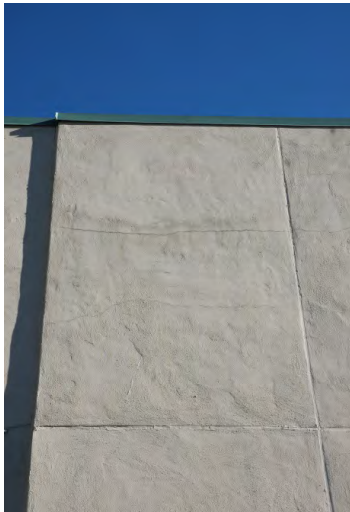
Face-sealed acrylic stucco in 1998 block shows signs of cracks and patching.

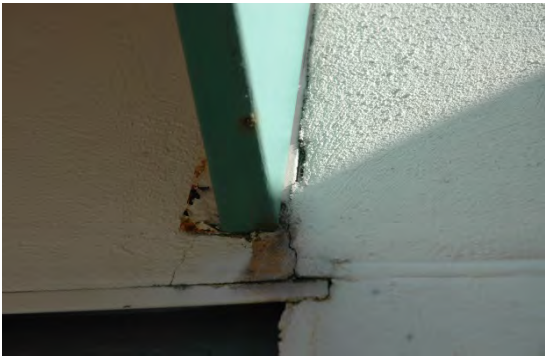
Stucco cracking and crumbling around canopy mounting bracket in 1998 block. Canopy support is rusting.

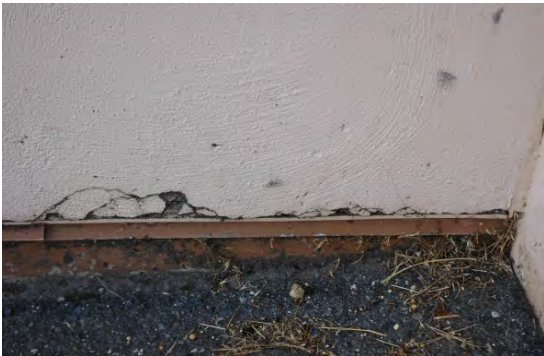
Stucco cracking and crumbling around wall base flashing in 1998 block

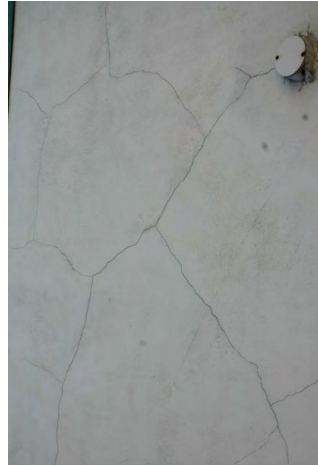
Extensive stucco cracking in 1998 block in courtyard.

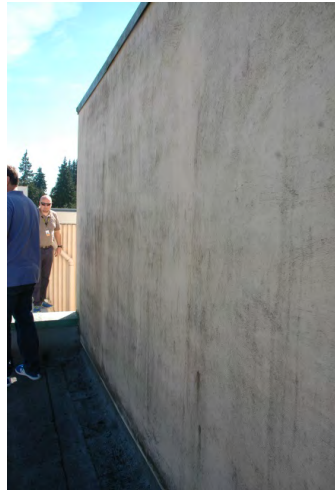
Extensive staining of face-sealed stucco probably indicates building envelope failure.

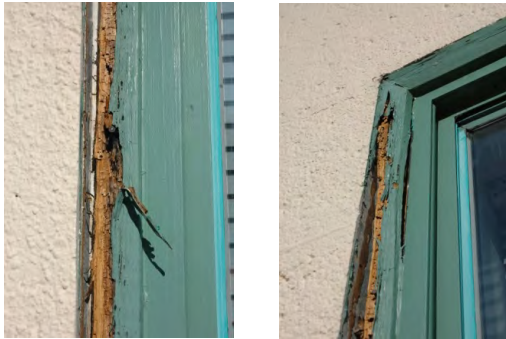
Deterioration of wood window trim on 1976 Block

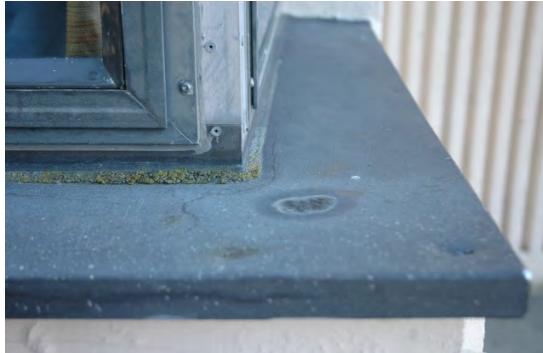
Window sills in east block are often not sloped to drain, which adds to risk of water ingress.

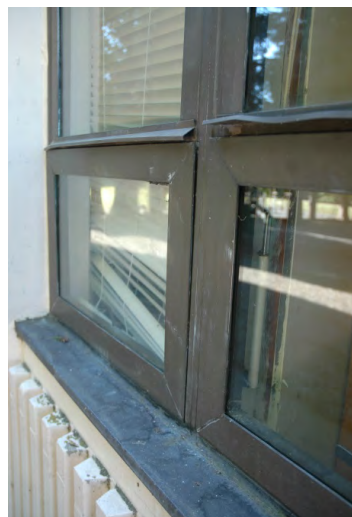
Some windows are visibly damaged and scratched. Lips added above opening vents indicate attempts to mitigate past leakage.

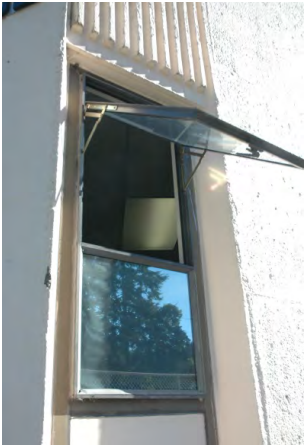
Awning vent in aluminum frame window. Lack of insect screens prevents use of window vents in areas of the school where wasps are a problem.

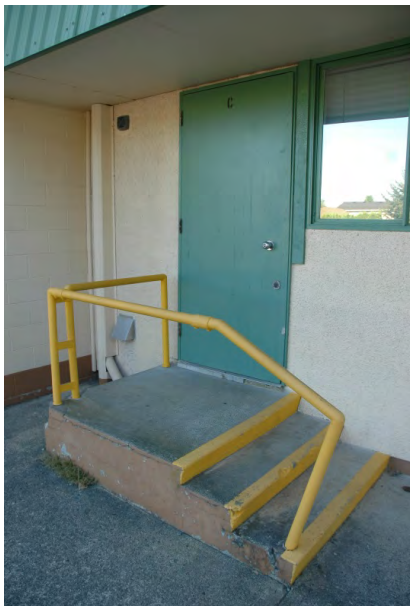
Stair railings and landing are not code compliant

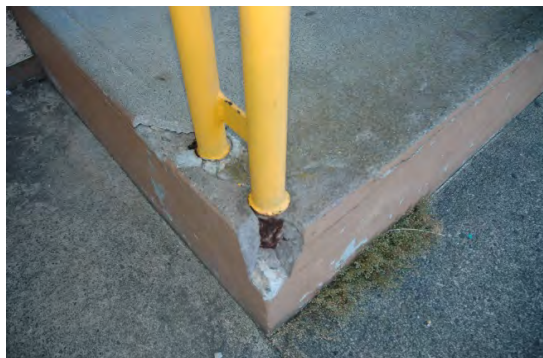
Railing embed into concrete is rusted and concrete is damaged.

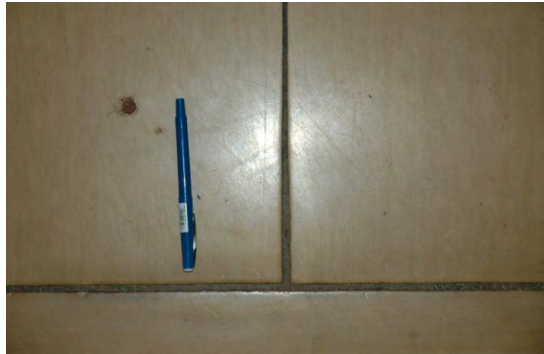
Old linoleum in corridors have large gaps where flooring has separated at joints.

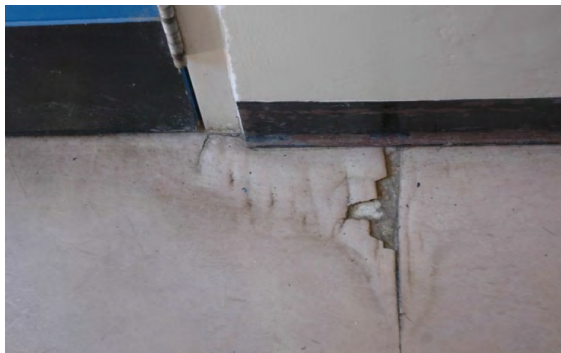
Flooring lifting off substrate creates a tripping hazard and is impossible to clean.

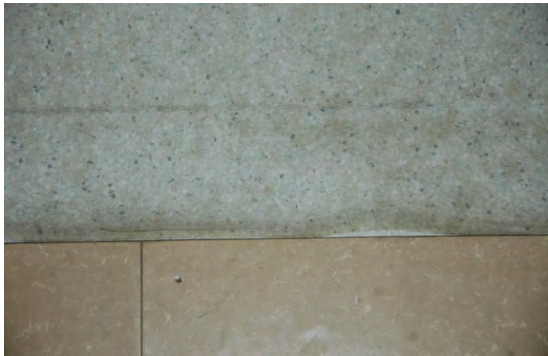
Junction of one old flooring to another with buckling at the joint.

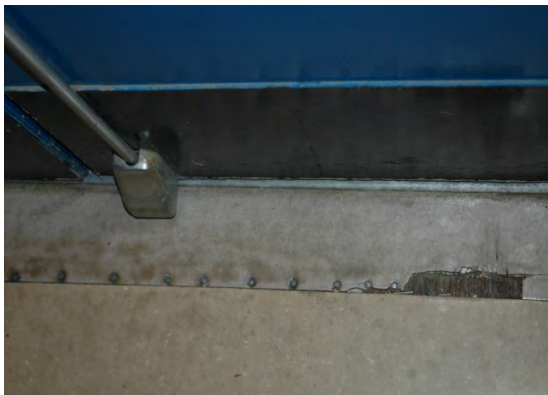
Patching at exterior door has chipped where floor is lifting. Nails used to prevent further buckling.

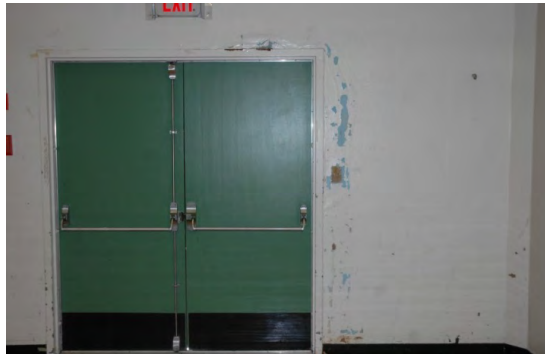
Damage and swelling of the wall finish in the gymnasium exterior wall suggests water leakage has occurred in the past.

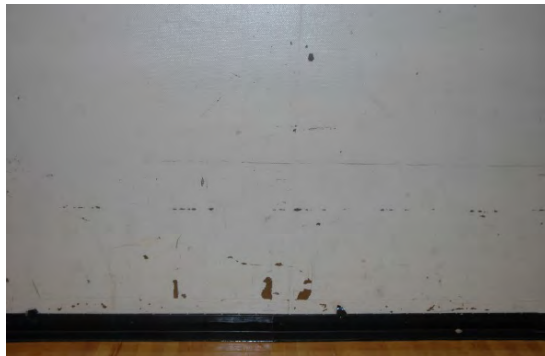
Fibreglass cloth wall protection is not adequate for gymnasium use, and difficult to repair.

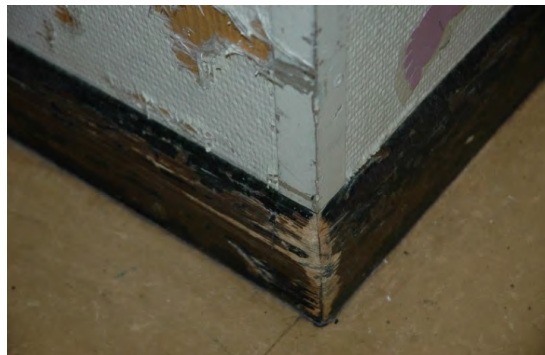
Fibreglass cloth wall protection and wood base in 1964 block corridor is badly damaged.

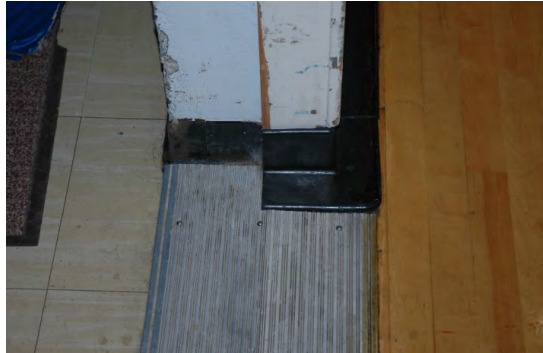
Opening to gym foyer shows significant wall damage.

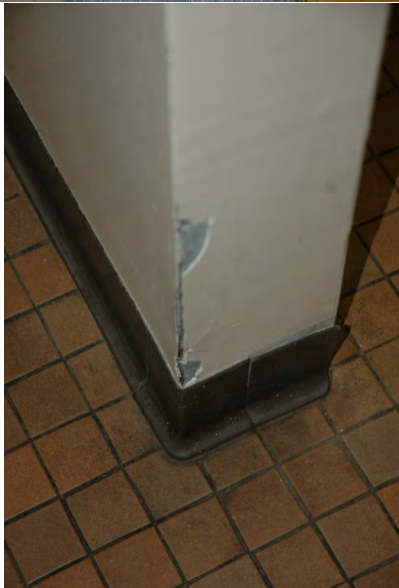
Painted gypsum wall in change room needs wall and/or corner protection.

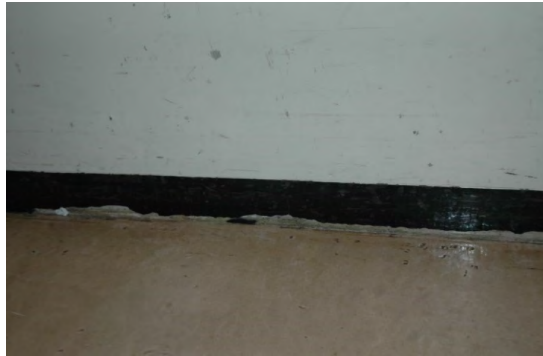
Chipped vinyl base in 1981 corridor.

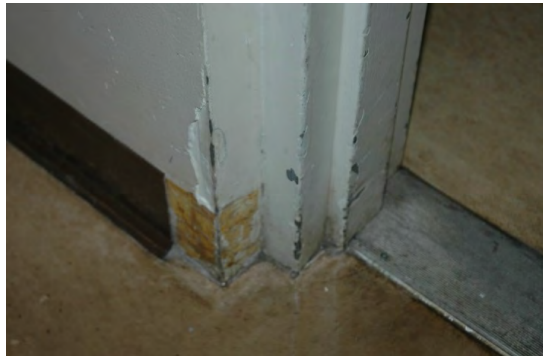
Damage to vinyl base, wall and door frame.

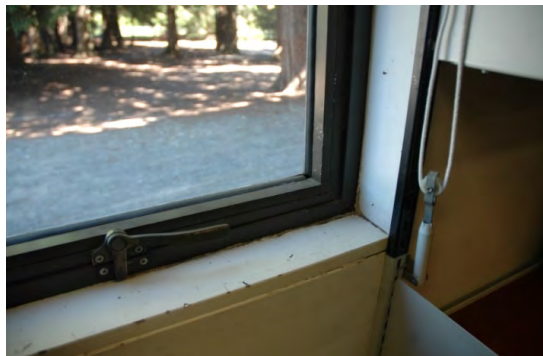
Evidence of condensation affecting wood window liner and sill.

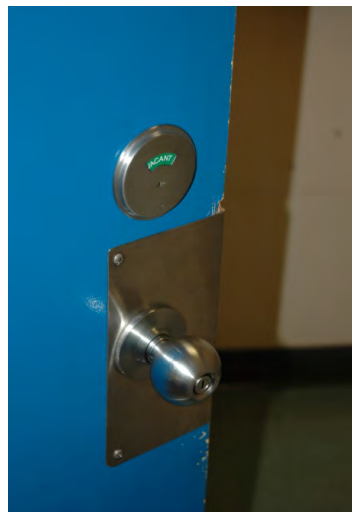
Knob handles are the norm in the older blocks of the school, and do not meet current code for accessibility.

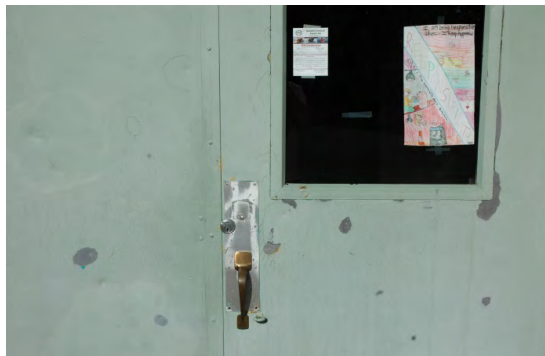
Door hardware is generally in fair to poor condition.

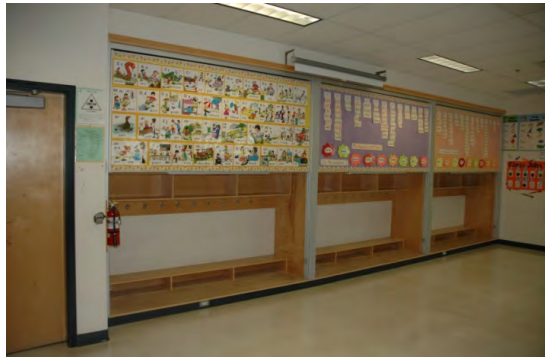
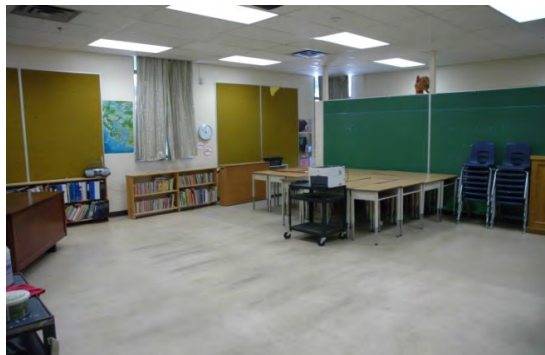
Millwork and fittings in the older blocks are generally of poor quality or condition.

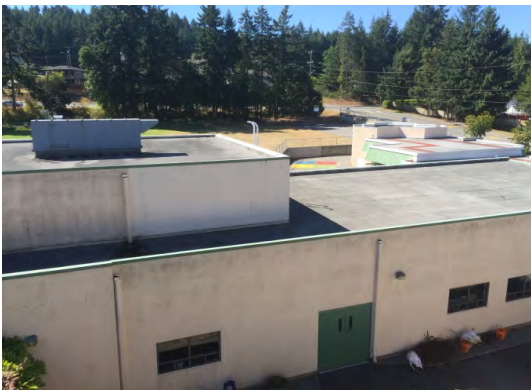
- No obvious condition issues identified however staining and crazing of the north side stucco may indicate envelope issues that could affect the wood frame structure behind:

Photo C –  
Exterior view of north elevation of block.  
(Note staining and crazing of stucco)

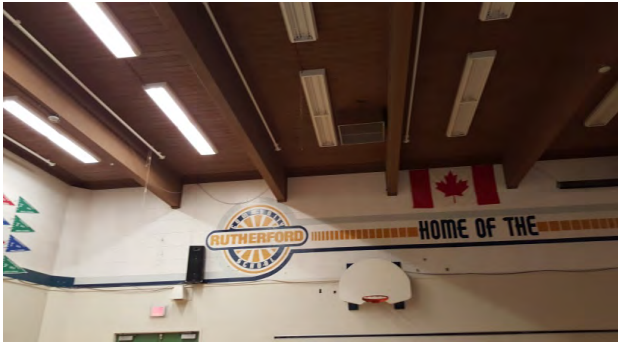
Gymnasium includes minimal ventilation. Recommend improved ventilation to meet current codes

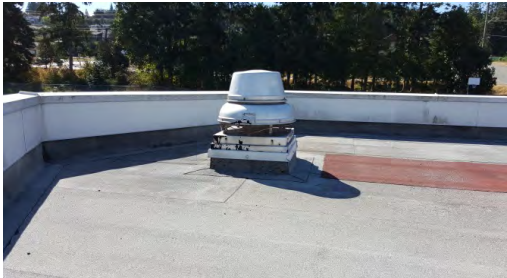
Exhaust Fan (typical). All exhaust fans are in poor condition and should be replaced.

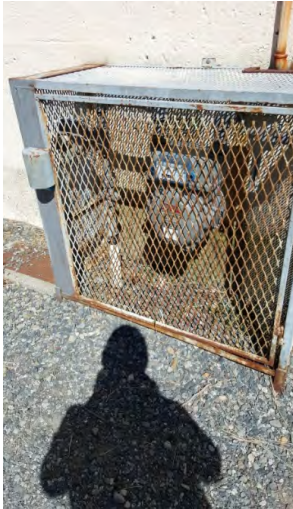
Original gas meter. Seismic valve should be added in service line.

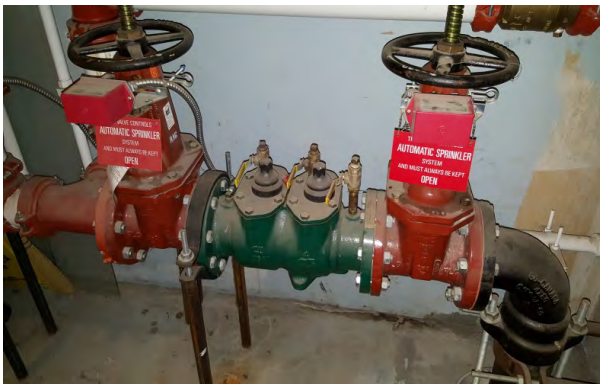
Main incoming fire service backflow preventer. Recommend yearly testing

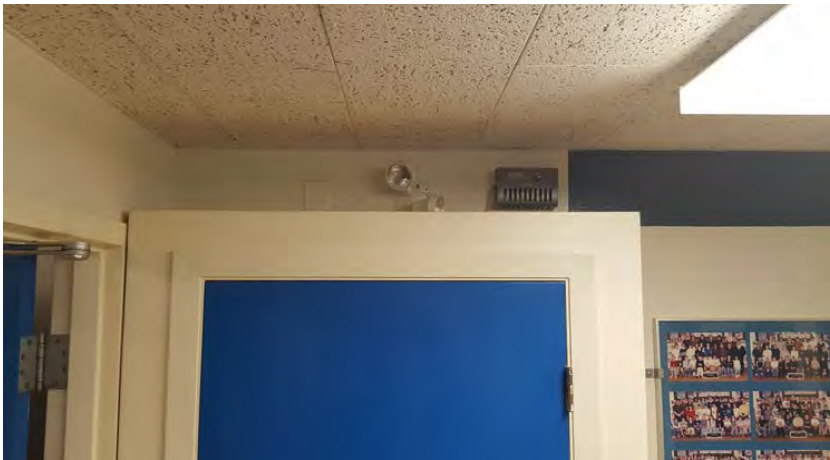
**Figure 1: Improper Emergency Light Installation**

The existing emergency lighting is installed improperly and does not provide sufficient lighting of exit pathways in the event of an emergency. Figure 1 depicts an example of where an emergency light has been installed in an area where the light cannot provide illumination of the floor area. New and additional fixtures are required throughout the school to meet the requirements of BCBC.
