Facility Condition Report

**SD No. 68 1. DM - Nanaimo-Ladysmith --
SOUTH WELLINGTON ELEMENTARY**

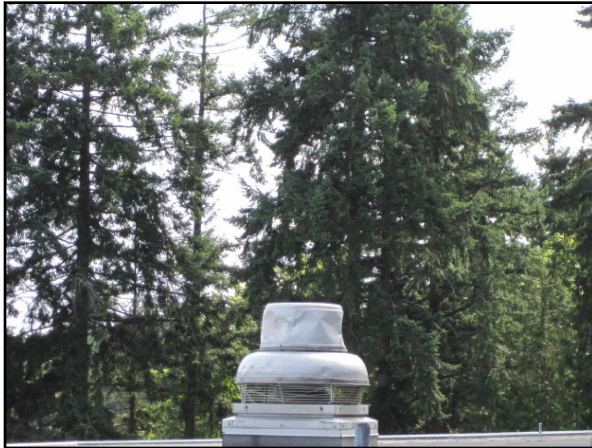
Exhaust System - General Building Renewal

Auto generated renewal for Exhaust System - General Building. System Description: The HVAC ventilation system includes rooftop exhaust fan.

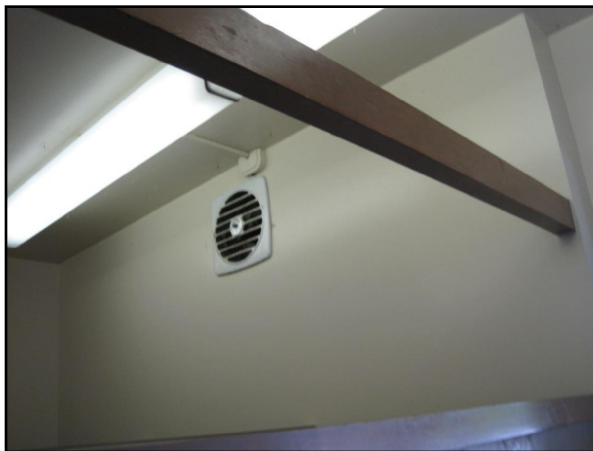
Exhaust System - Residential Type Renewal

Auto generated renewal for Exhaust System - Residential Type. System Description: HVAC ventilation system includes residential type exhaust fans located in the building.

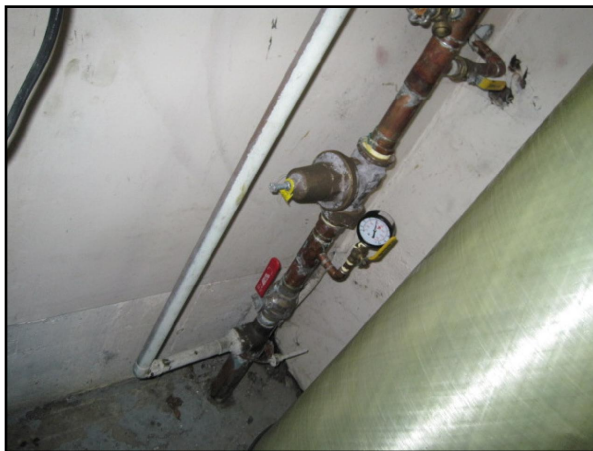
Water Dist Complete Renewal

Auto generated renewal for Water Dist Complete. System Description: The building domestic water system includes a main water supply line entering in the mechanical furnace room with associated distribution piping. Water is feed from a water well, located in the pump house (outside).

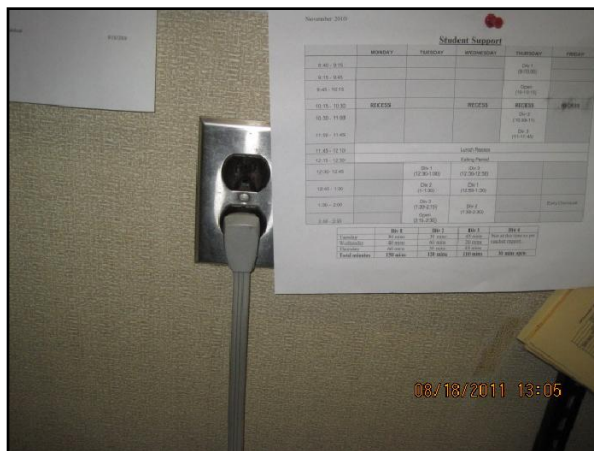
Branch Wiring - Equipment Devices Renewal

Auto generated renewal for Branch Wiring - Equipment & Devices. System Description: Branch wiring for this building includes interior and exterior branch wiring, devices, and utilization equipment. The system is aged beyond the BOMA life expectancy of 30 years and replacement should be planned.

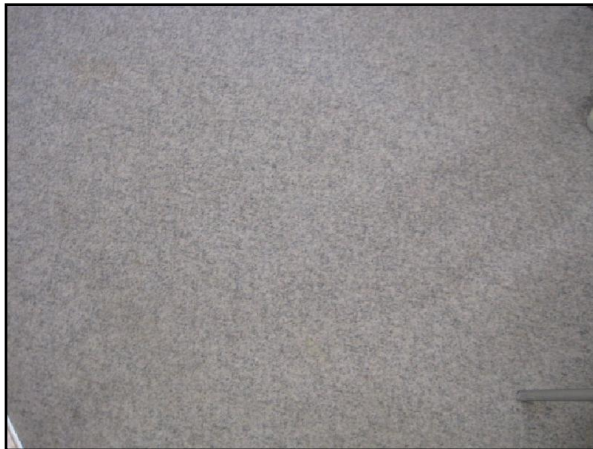
Carpeting - Broadloom Renewal

Auto generated renewal for Carpeting - Broadloom. System Description: Floor finishes include medium priced carpeting and base. System quantities are estimated for budgetary purposes only. Actual replacement quantities are subject to site verification by others.

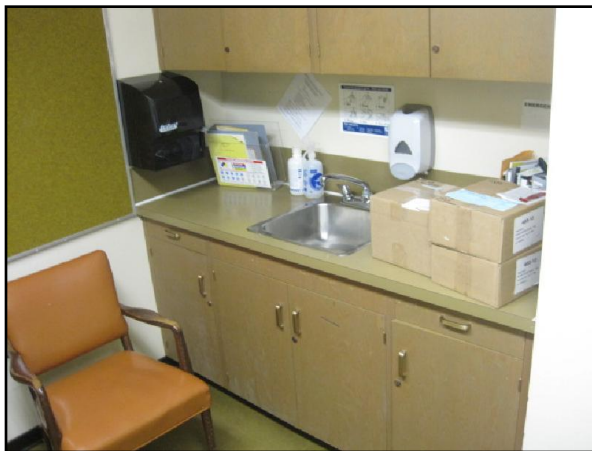
Casework - Elementary School Renewal
Casework - Elementary School Renewal

Auto generated renewal for Casework - Elementary School. System Description: The building includes typical classroom, library, kitchen, administration and office casework for an elementary school. System quantities are estimated for budgetary purposes only. Actual replacement quantities are subject to site verification by others.

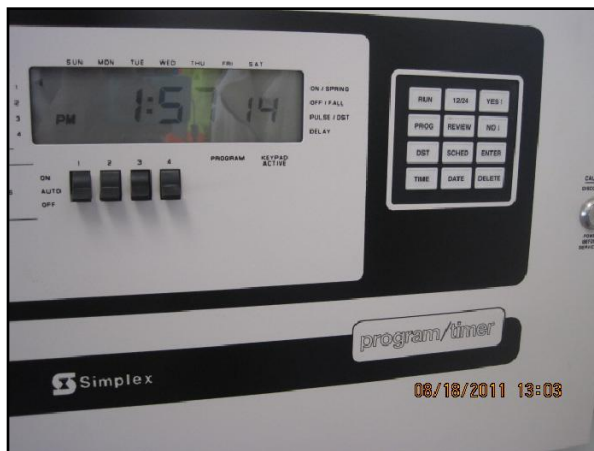
Clock System Renewal

Auto generated renewal for Clock System. System Description: The building has a Simplex clock system that includes master control station, clocks, wire, fittings. The system is aged beyond the BOMA life expectancy of 10 years and replacement should be planned.

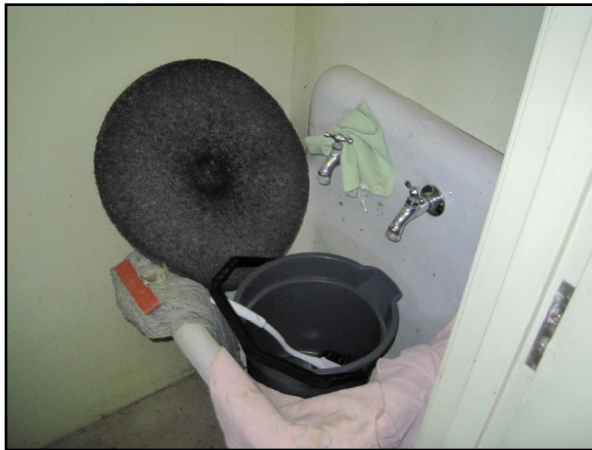
Custodial Sink Renewal

Auto generated renewal for Custodial Sink. System Description: The plumbing fixtures include wall hung custodial sink.

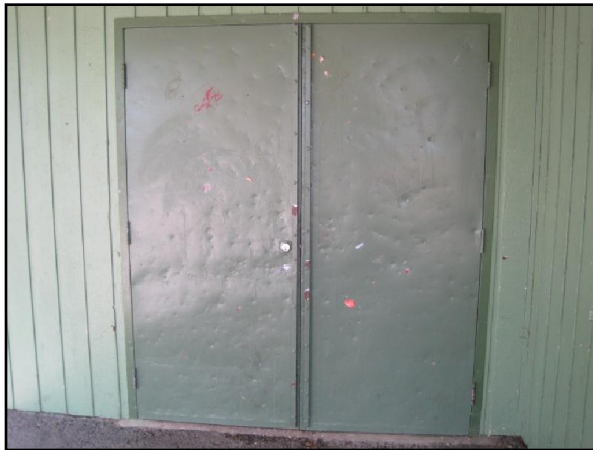
Door Assembly - Double Renewal

Auto generated renewal for Door Assembly - Double. System Description: Exterior doors include double-leaf doors and frames with standard hardware.

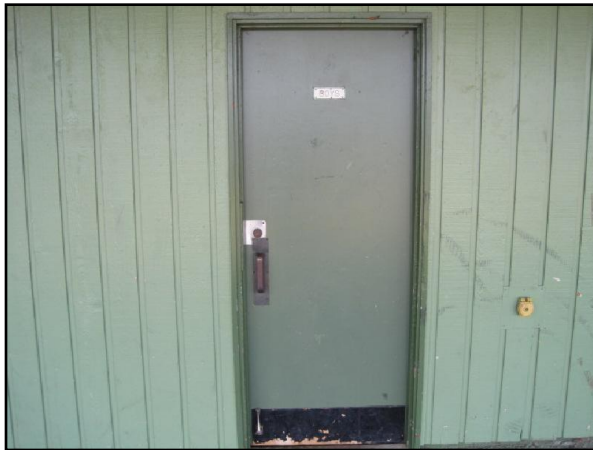
Door Assembly - Single Renewal

Auto generated renewal for Door Assembly - Single. System Description: Exterior doors include single-leaf door and frames with standard hardware.

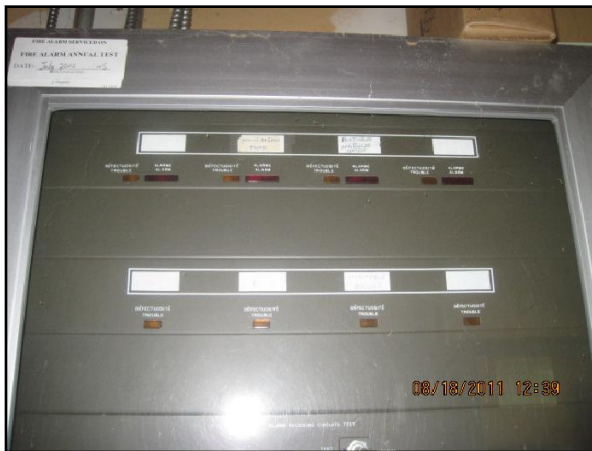
Fire Alarm System Renewal

Auto generated renewal for Fire Alarm System. System Description: The building is provided a fire alarm system that includes Edwards 6500 master control panel, annunciator, manual pull stations, smoke detectors, heat detectors, and audible bell and visual alarms. The system is aged beyond the BOMA life expectancy of 20 years and replacement should be planned.

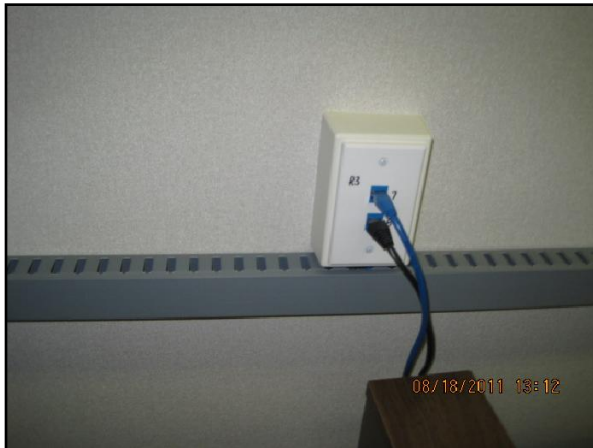
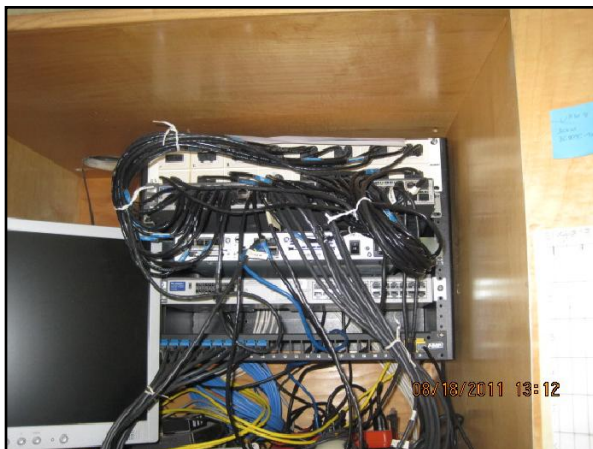
LAN System Renewal

Auto generated renewal for LAN System. System Description: The building includes local area network wiring Cat5/Cat5e and RJ-45 Terminations. Ethernet equipment such as routers and switches is considered owner equipment, hence, is excluded here. The system is approaching the end of BOMA life expectancy of 15 years and replacement should be planned.

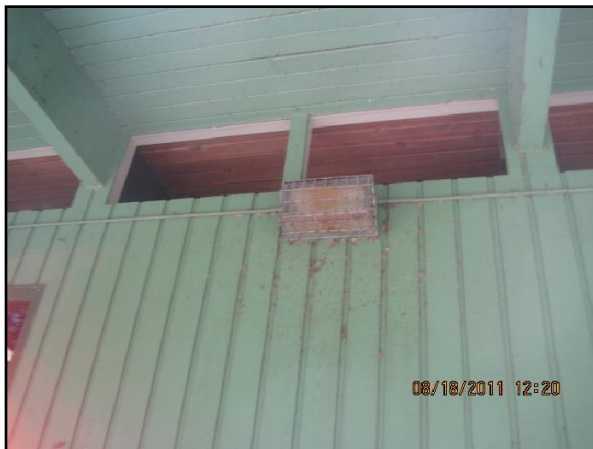
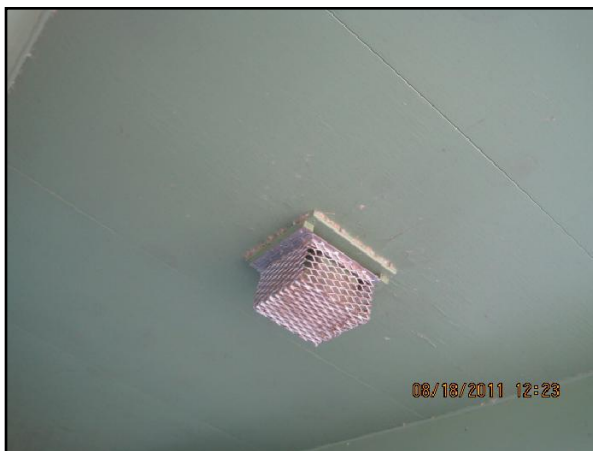
Lighting - Exterior Renewal

Auto generated renewal for Lighting - Exterior. System Description: Exterior lighting consists of wall mounted and under canopy HID fixtures. The system is aged beyond the BOMA life expectancy of 20 years and replacement should be planned.

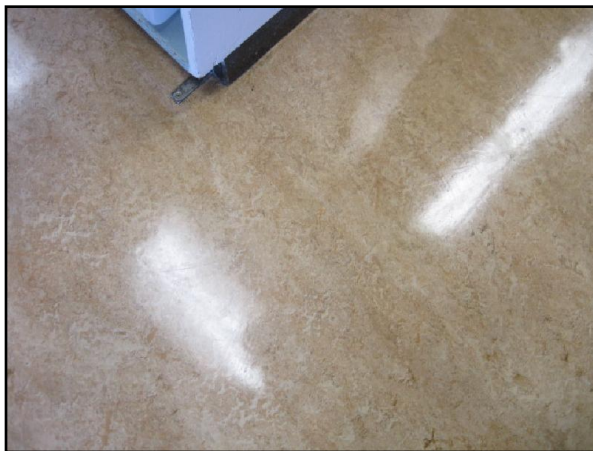
Linoleum Sheet Goods Renewal

Auto generated renewal for Linoleum Sheet Goods. System Description: Floor finishes include areas of linoleum and or marmoleum sheet goods flooring and related base. System quantities are estimated for budgetary purposes only. Actual replacement quantities are subject to site verification by others.

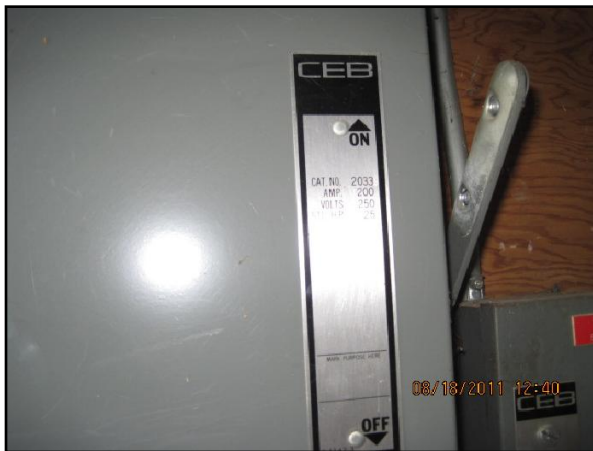
Main Electrical Service - 200A 120/240V Renewal

Auto generated renewal for Main Electrical Service - 200A 120/240V. System Description: The building includes a typical electrical service, which includes incoming feeders, 200A main disconnect, disconnects, CT section, and metering. The system is aged beyond the BOMA life expectancy of 30 years and replacement should be planned.

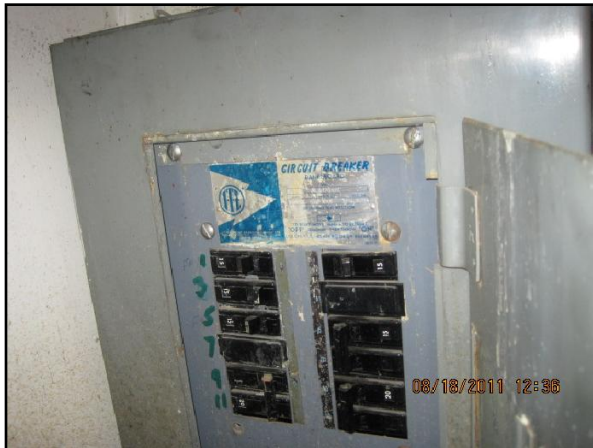
Panelboards, Feeders and Disconnects - 120/240V Renewal

Auto generated renewal for Panelboards, Feeders and Disconnects - 120/240V. System Description: The electrical distribution system includes 100 and 200 amp panelboards, disconnects and associated equipment. The system is aged beyond the BOMA life expectancy of 30 years and replacement should be planned.

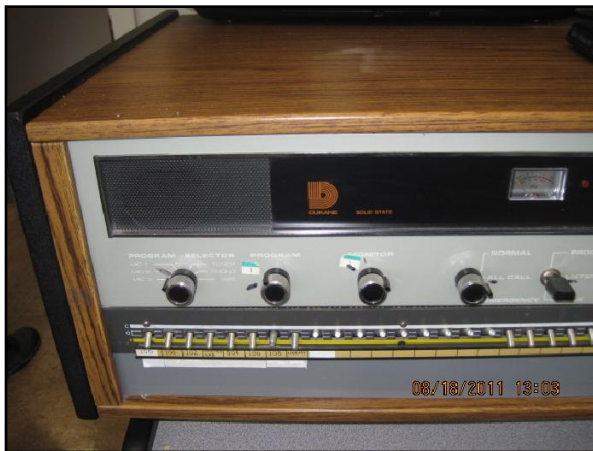
Public Address System Renewal

Auto generated renewal for Public Address System. System Description: The public address system includes a Dukane master console, speakers, conduit and shielded wiring. The system is aged beyond the BOMA life expectancy of 20 years and replacement should be planned.

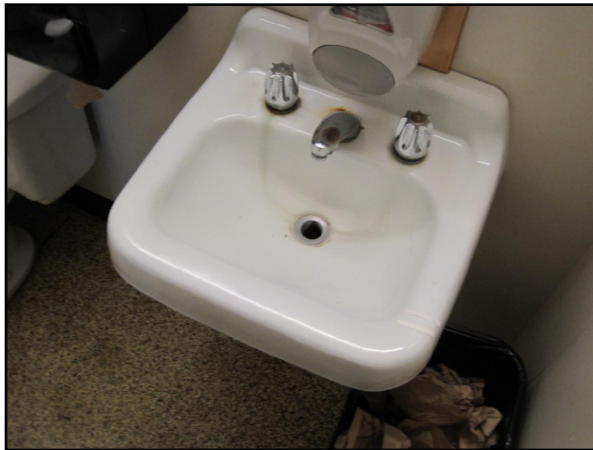
Restroom Fixtures - 1969 Renewal

Auto generated renewal for Restroom Fixtures - 1969. System Description: The restroom fixtures include vitreous china water closets and lavatories.

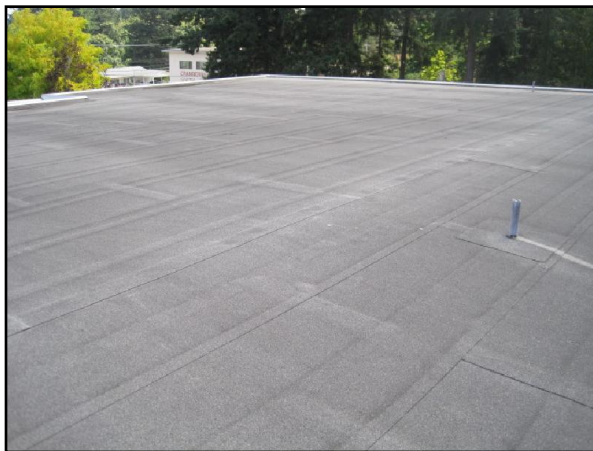
SBS Modified Bitumen Membrane Renewal

Auto generated renewal for SBS Modified Bitumen Membrane. System Description: The building's insulated roof is finished with an SBS Granulated Bitumen Membrane type. The cost estimate includes rigid insulation.

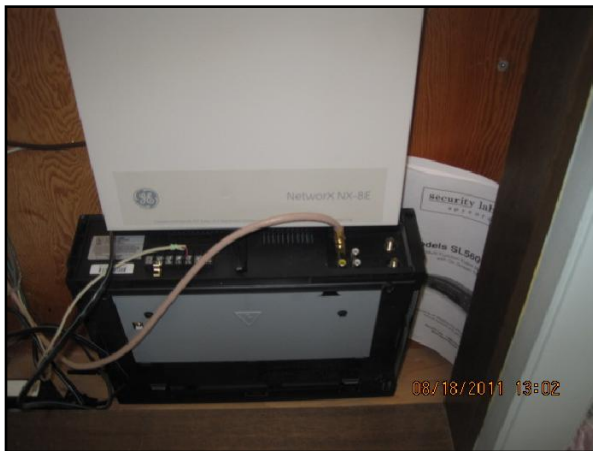
Security System Renewal

Auto generated renewal for Security System. System Description: The school is equipped with a security system which monitors access and unauthorized entry with keypads, motion detectors and alarm monitoring audible sound systems. The system includes Legend100 control panel. The system is aged beyond the BOMA life expectancy of 10 years and replacement should be planned.

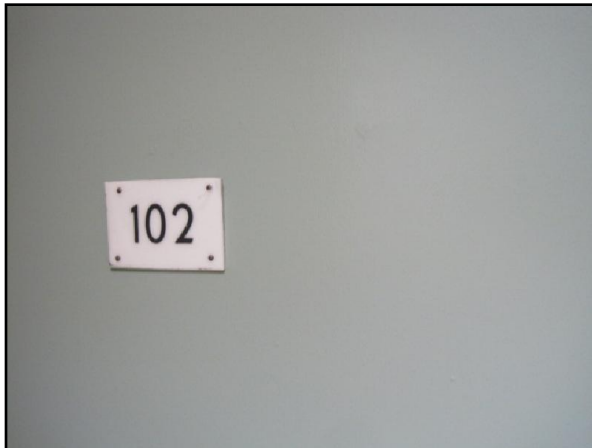
Signage (Room Numbering and Identification) Renewal

Auto generated renewal for Signage (Room Numbering and Identification). System Description: The building has way finding signage which typically includes door numbers, names and graphics. System quantities are estimated for budgetary purposes only. Actual replacement quantities are subject to site verification by others.

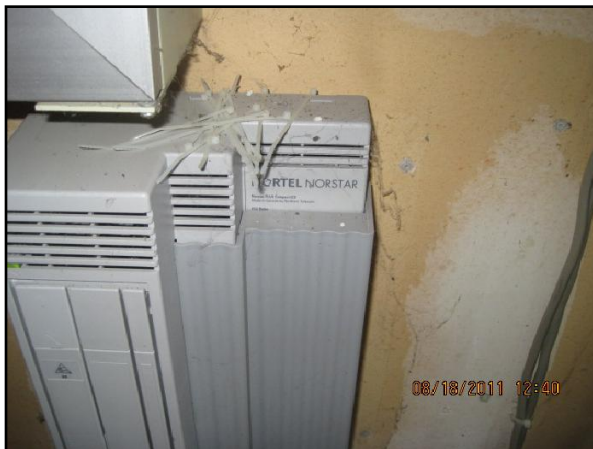
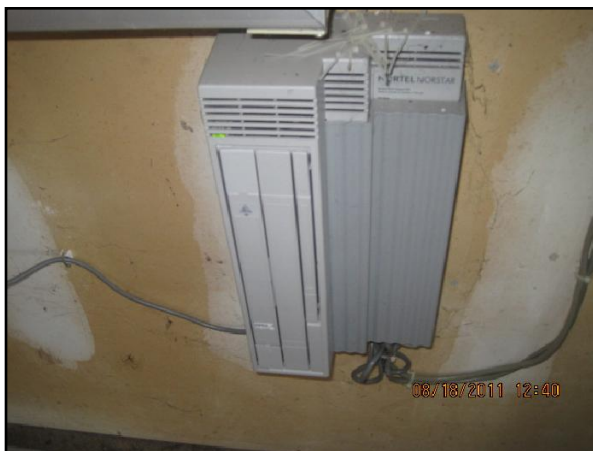
Telephone System Renewal

Auto generated renewal for Telephone System. System Description: The school has Nortel telephone system that includes cabling, RJ-11 Terminations and BX-panels. The system is aged beyond the BOMA life expectancy of 20 years and replacement should be planned.

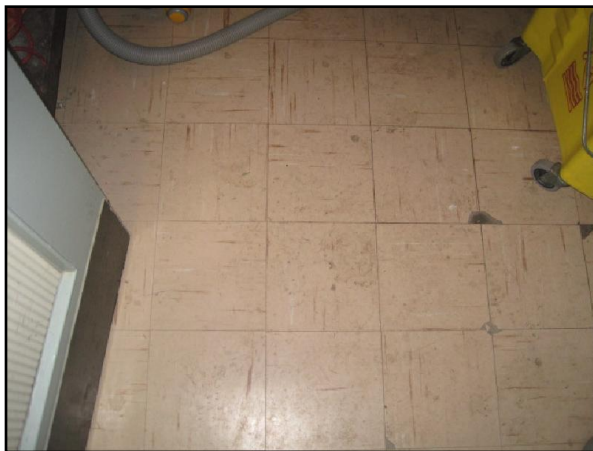
Vinyl Composite Tile Standard Renewal

Auto generated renewal for Vinyl Composite Tile Standard. System Description: Floor finishes include areas of standard VCT flooring and related base. System quantities are estimated for budgetary purposes only. Actual replacement quantities are subject to site verification by others.

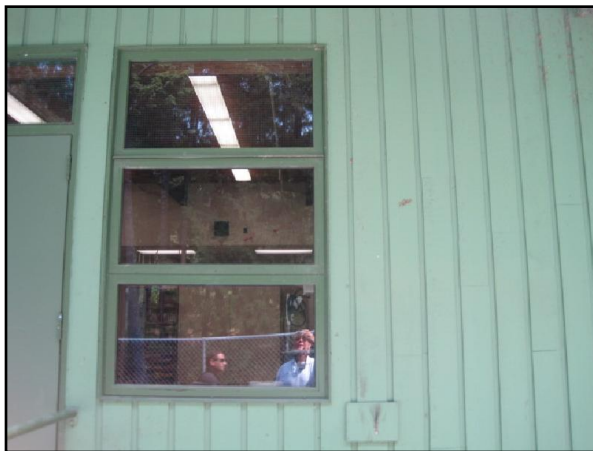
Windows - Metal Renewal

Auto generated renewal for Windows - Metal. System Description: The building includes metal framed exterior units with non-insulating glass. System quantities are estimated for budgetary purposes only. Actual replacement quantities are subject to site verification by others.

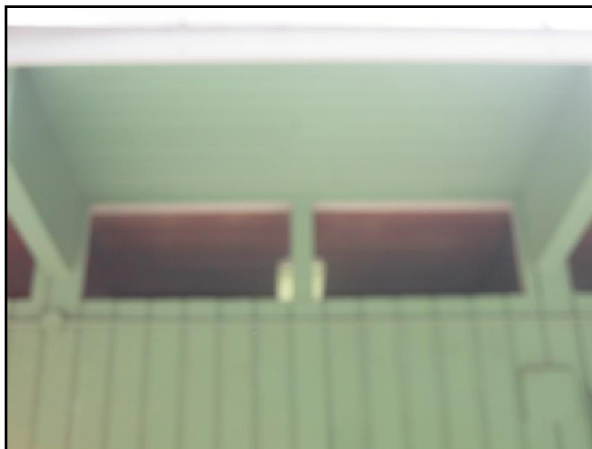
Windows - Wood Renewal

Auto generated renewal for Windows - Wood. System Description: The building includes wood framed exterior units with non-insulating glass. System quantities are estimated for budgetary purposes only. Actual replacement quantities are subject to site verification by others.

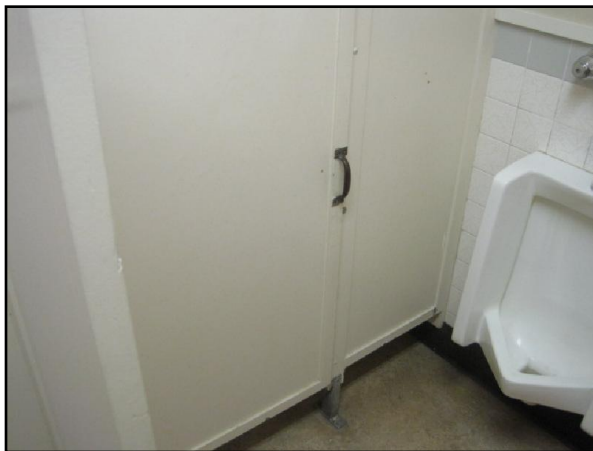
Wood Partitions Washrooms Renewal

Auto generated renewal for Wood Partitions Washrooms. System Description: The washrooms are equipped with floor mounted painted wood toilet partitions.

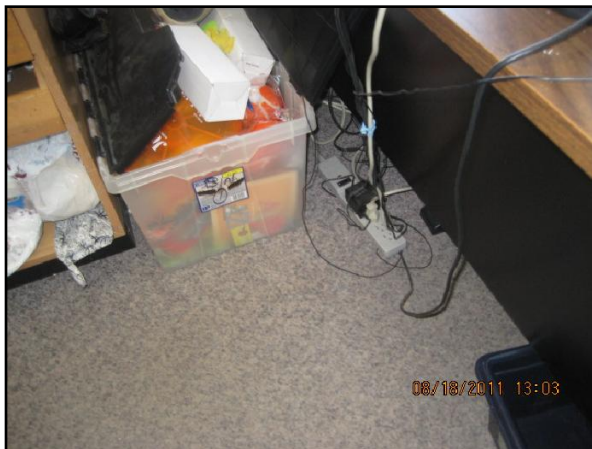
Branch Wiring Devices - Insufficient Quantity of Receptacles

The number of branch circuits and receptacles is insufficient in some of the rooms and multi-outlet extensions were observed.

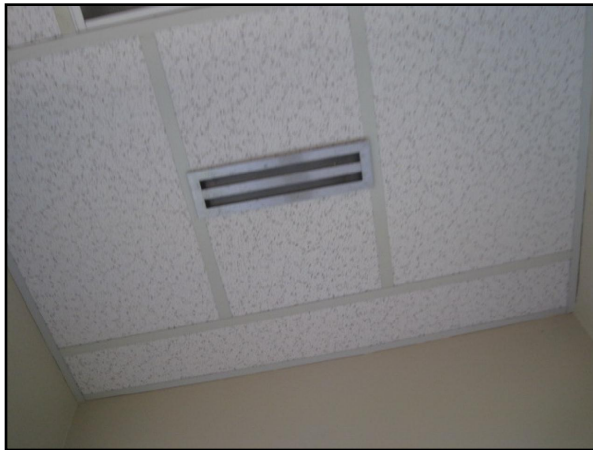
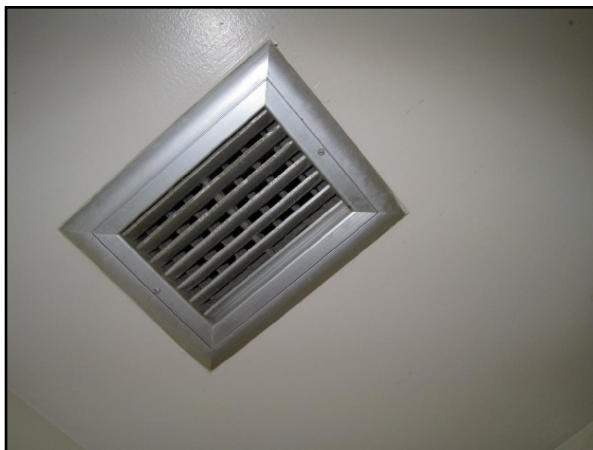
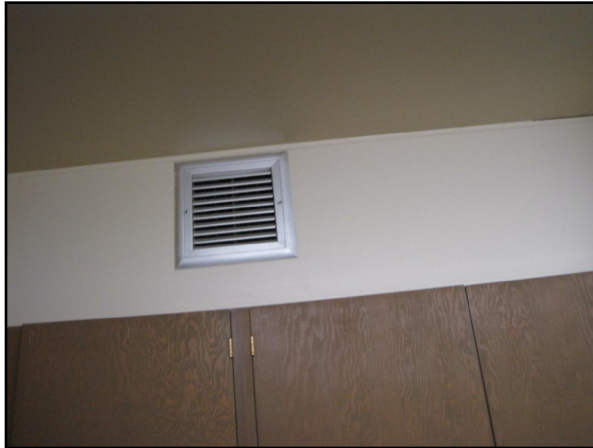
Distribution Systems - HVAC Ductwork Dirty

Observed during the assessment were many supply and exhaust diffusers were coated with dust and dirt. Ductwork cleaning is recommended.

Clean all supply, return and the exhaust ductwork throughout the building. Repaired as necessary and rebalance all ductwork after cleaning.

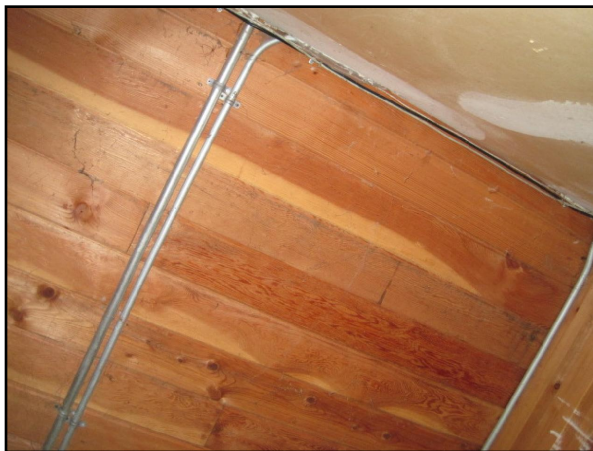
Distribution Systems - Ventilation System Not Installed

The electrical room does not have any exhaust ventilation system installed. Installation of one would improve work place safety and indoor air quality.

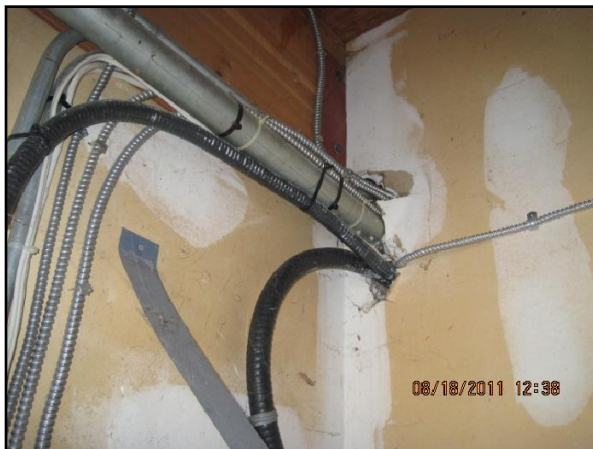
Electrical Conduits - Fire Stopping Not Installed

The electrical conduits in electrical room 1319 do not have fire stopping installed as required by BCBC 2006 Section 3.1.9.1.

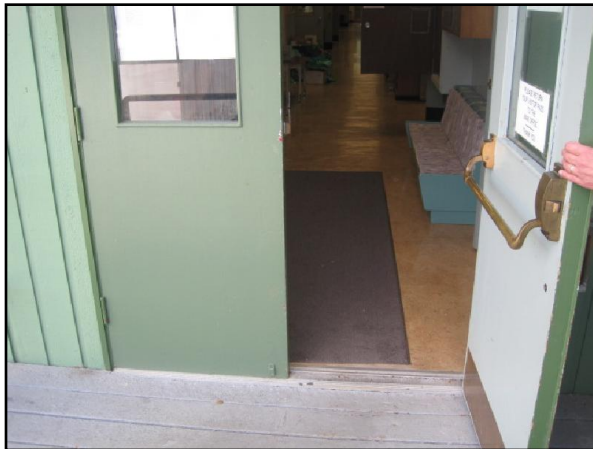
Exterior Doors - Automatic Door Openers Lacking at Entry

The entrance doors do not have automatic door openers installed in accordance with BC Building Code Article 3.8.2.17.

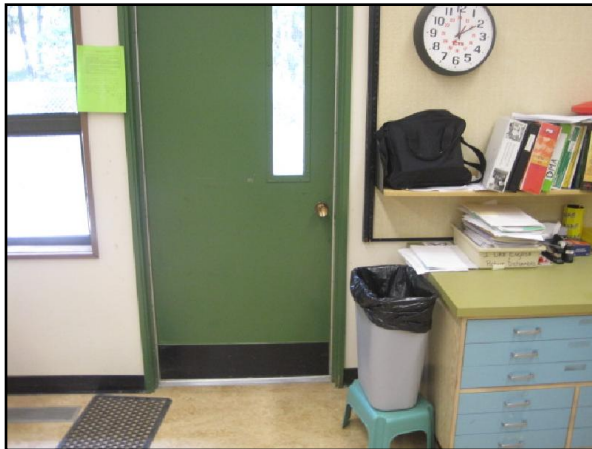
Interior Doors - Hardware Not Accessible

The knob door hardware in the facility does not conform to the requirements of the 2006 British Columbia Building Code section 3.3.1.13.10)c) as the door handles require tight grasping or twisting of the wrist to operate.

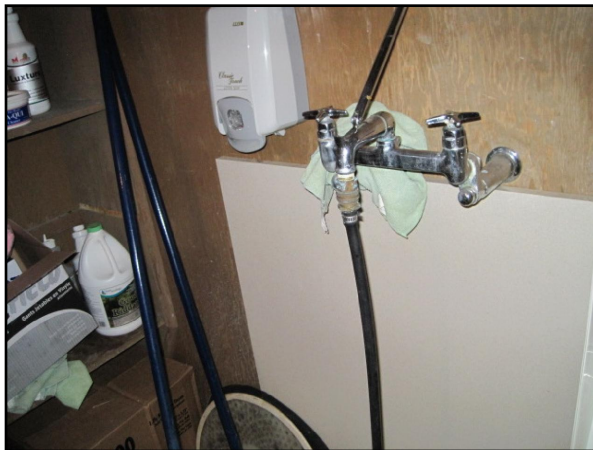
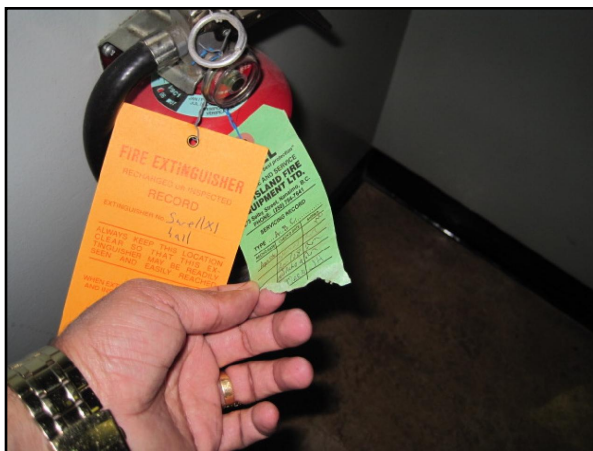
Various Mechanical Deficiencies

- 1) CNFC section 6.2.1.1 refers to NFPA Chapter 10 for installation of fire extinguishers. According to NFPA Chapter 10 Section 7.2.4.3 monthly inspection of fire extinguishers should be conducted and initials of the person performing the inspection shall be recorded.
- 2) The custodial sinks do not have back-siphonage protection as required by 2006 BCBC Section 7.6.2.2.

Repair mechanical deficiencies.

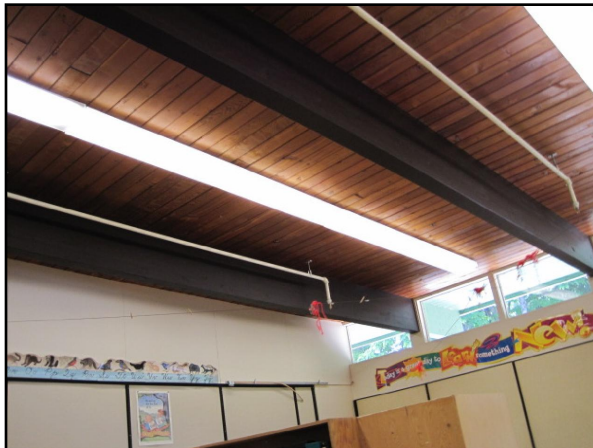
Fire Protection - Sprinkler Piping - No Seismic Restraint

The sprinkler piping in the classrooms is not seismically restrained to prevent falling. When rated per National Standard of Canada - CAN/CSA - S832-06 entitled "Seismic Risk Reduction of Operational and Functional Components of Building", these sprinkler piping had a risk index score of 20.4000.

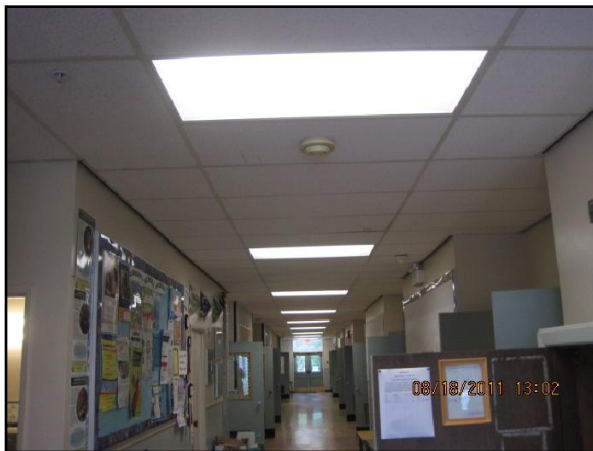
Non-Seismic Luminaire - Corridors

Light fixtures, especially recessed type, in the corridors are not seismically secured.

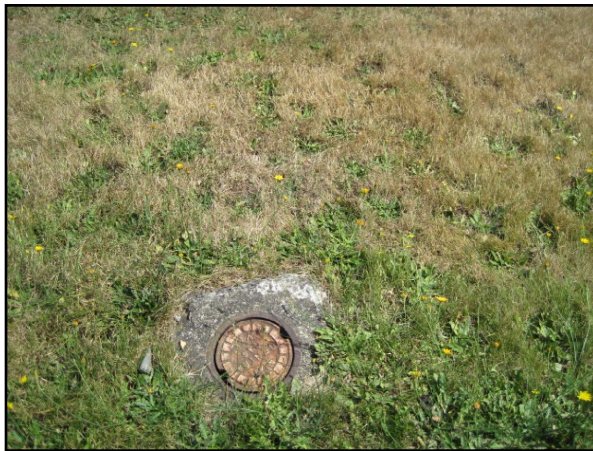
Underground Oil Tank - Steel Renewal

Auto generated renewal for Underground Oil Tank - Steel. System Description: An underground oil storage tank is located on the property line.

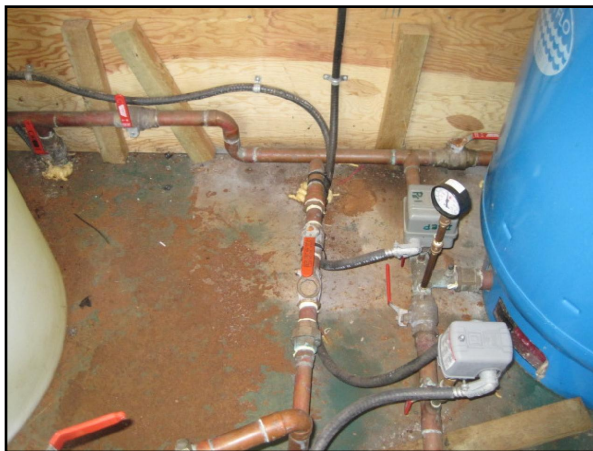
Water Supply Piping Renewal

Auto generated renewal for Water Supply Piping. System Description: The site includes main water supply line with associated valves and distribution piping. The water is feed from the water well, located in the pump house.

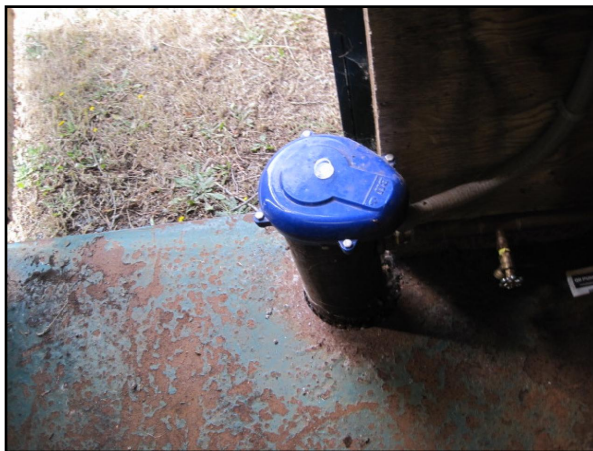
Water Well Renewal

Auto generated renewal for Water Well. System Description: System includes water well located in the pump house that supplies domestic water to the facility.
