SCHOOL DISTRICT No. 68  
Nanaimo-Ladysmith  
**RUTHERFORD ELEMENTARY SCHOOL**  
**BUILDING CONDITION ASSESSMENT**

September 2016

# RUTHERFORD ELEMENTARY SCHOOL BUILDING CONDITION ASSESSMENT

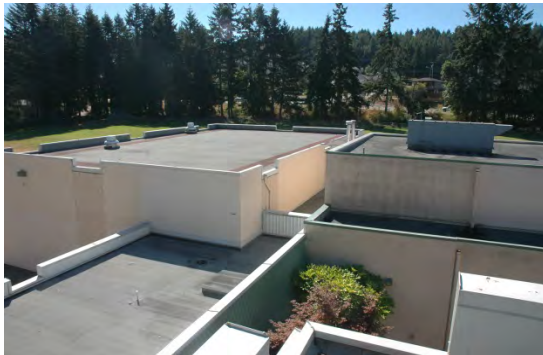
Roofscape at south end of building

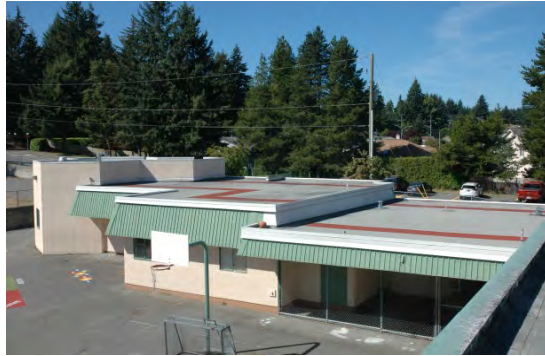
Roofscape at northwest corner of building

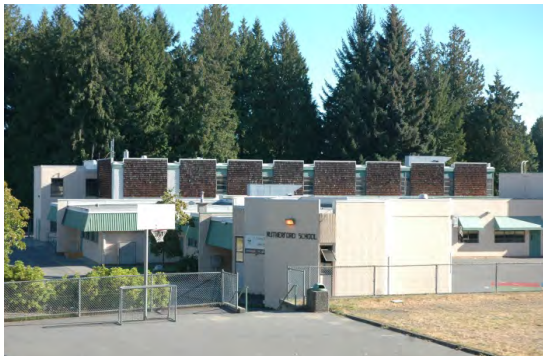
View of walls at north end of building.

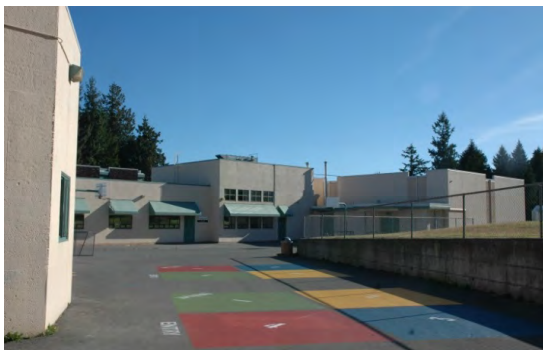
View of walls on west side of building.

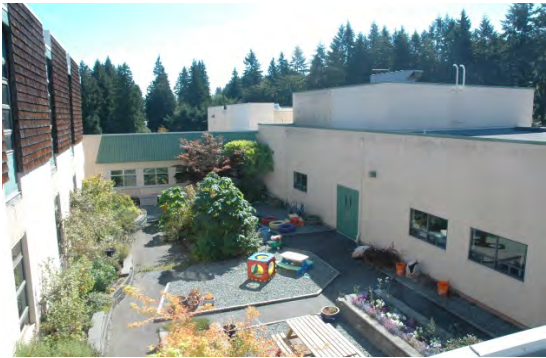
View of walls in courtyard.

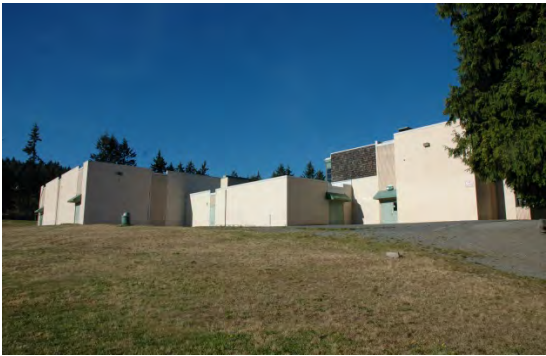
View of mostly concrete walls on south end of building.

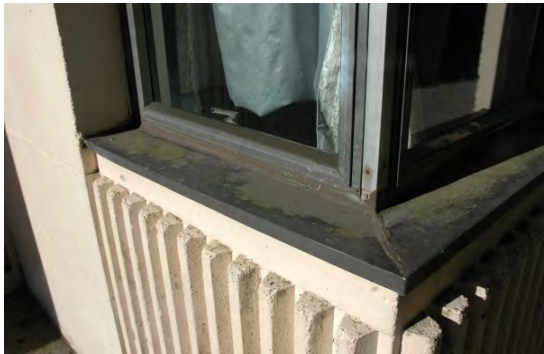
Typical window is single glazed with prefinished aluminum frame and sill flashings.

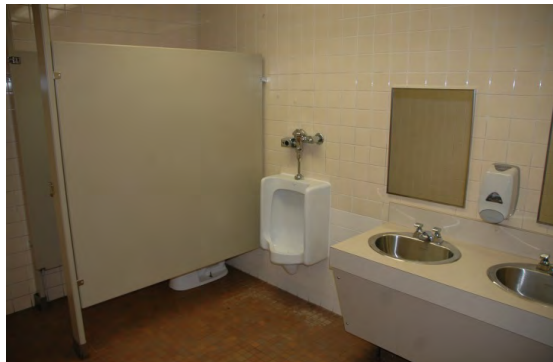
Washroom vanity faucet handles do not meet code for accessibility requirements. Metal toilet partitions used for non-accessible toilet stall. Urinal lacks code required grab bar and vanity mirror also doesn't meet code for accessibility.

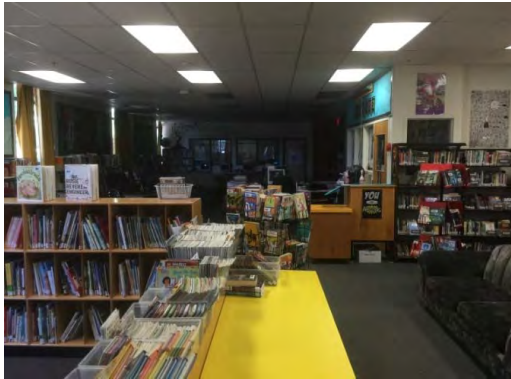
Photo C-  
Typical interior view (in this case the ground  
floor library). Note T bar ceiling hides drywall  
ceiling above.

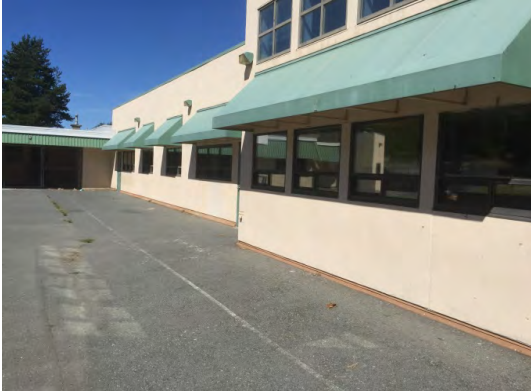
Photo A –  
Typical exterior view of southern exposure.

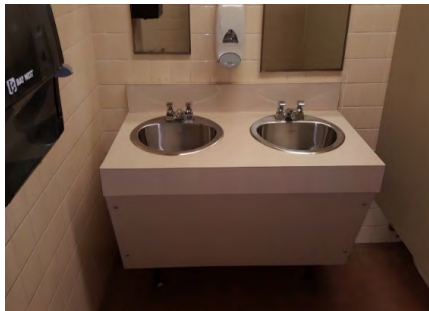
Washroom Lavatory (typical)

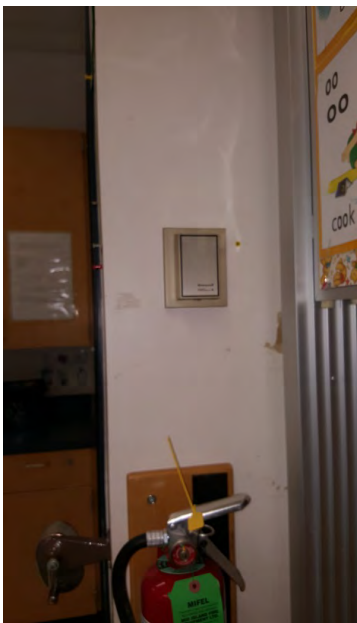
Thermostat for control of local  
heating system components

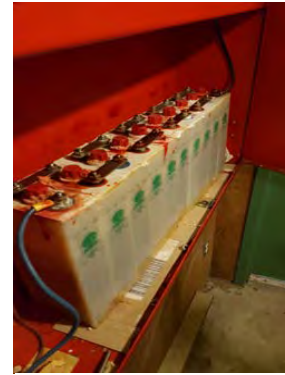
**Figure 2: Fire Alarm Batteries**

Figure 2 shows the buildup of corrosion on the poles of the fire alarm system backup batteries. These batteries should be maintained frequently and replaced every 5 years.
