SCHOOL DISTRICT No. 68  
Nanaimo-Ladysmith  
**RUTHERFORD ELEMENTARY SCHOOL**  
**BUILDING CONDITION ASSESSMENT**

September 2016

# RUTHERFORD ELEMENTARY SCHOOL BUILDING CONDITION ASSESSMENT

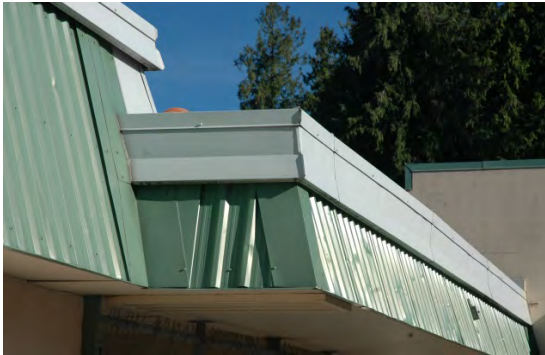
Typical metal canopy with plywood soffit

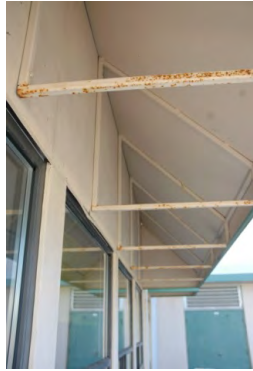
Metal canopy support within open soffit is rusting

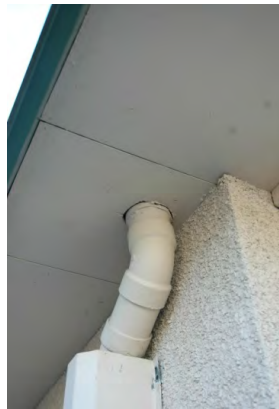
Painted plywood soffits are typical where there are overhangs.

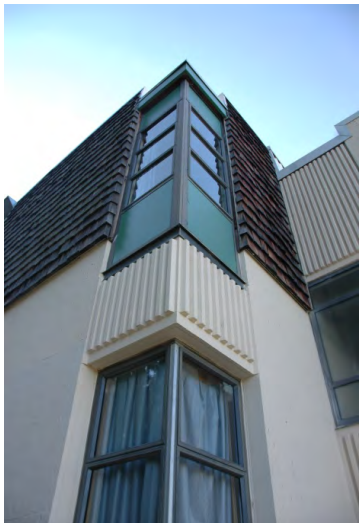
Typical corner window treatment in east block

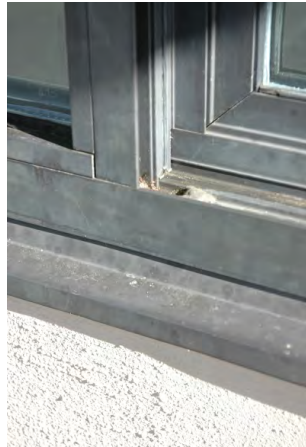
Aluminum finish has faded.

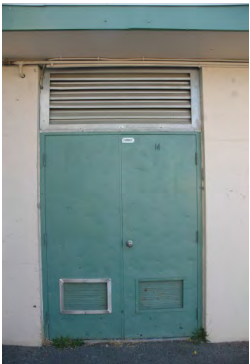
Typical exterior door in poor condition.

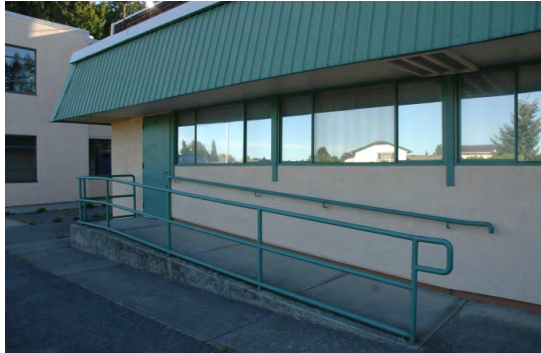
Ramp to Life Skills Room.

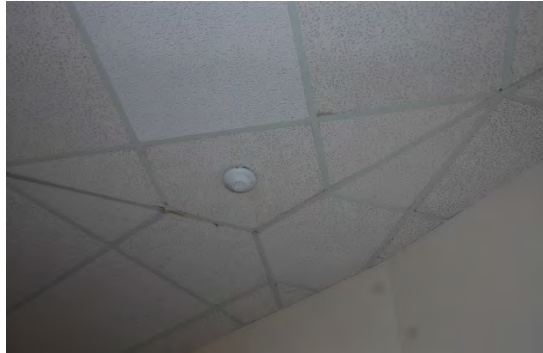
T-bar ceiling in 1976 admin wing showing one new acoustic panel among the older panels.

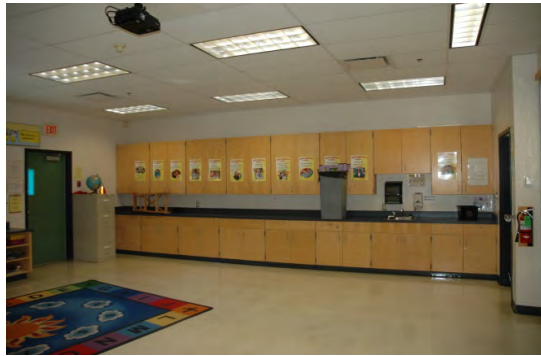
Typical t-bar ceiling in 1998 wing.

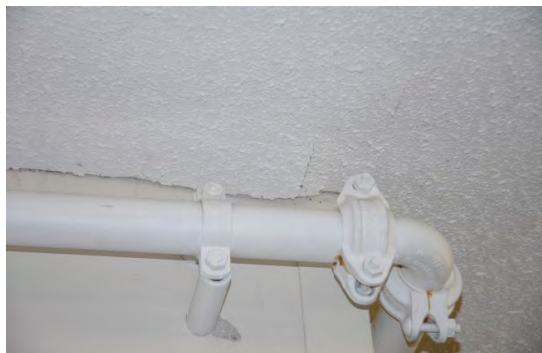
Swelling in textured ceiling above sprinkler pipe in 1981 gymnasium block.

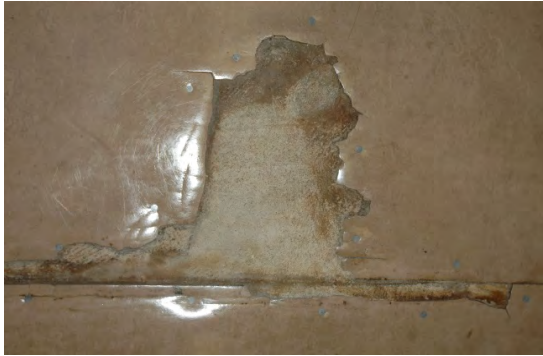
Second floor of 1981 block has significant problem with lifting floors and substrate.

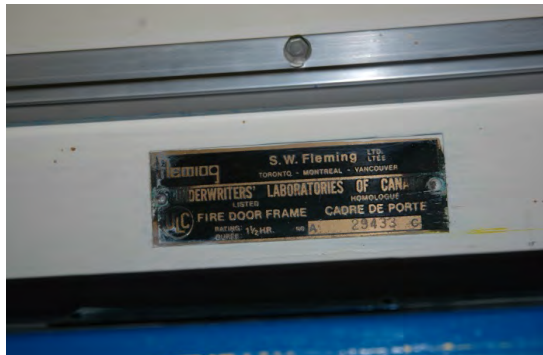
Two hallway door openings have labels for fire ratings.

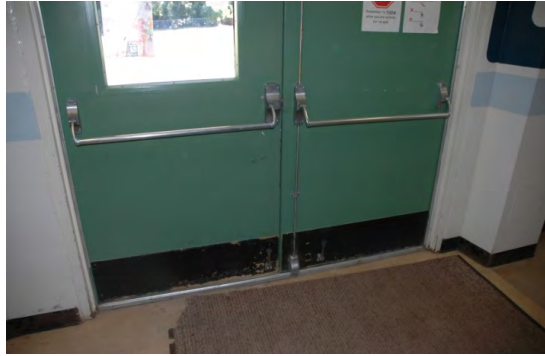
Typical exit hardware, kick plates and door threshold..

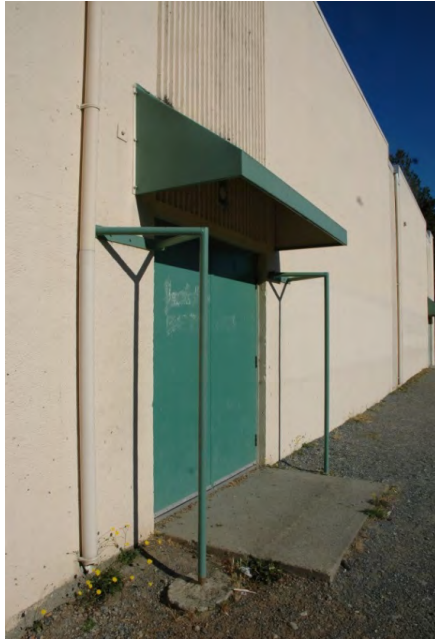
Pipe rail door stops beside gymnasium doors.

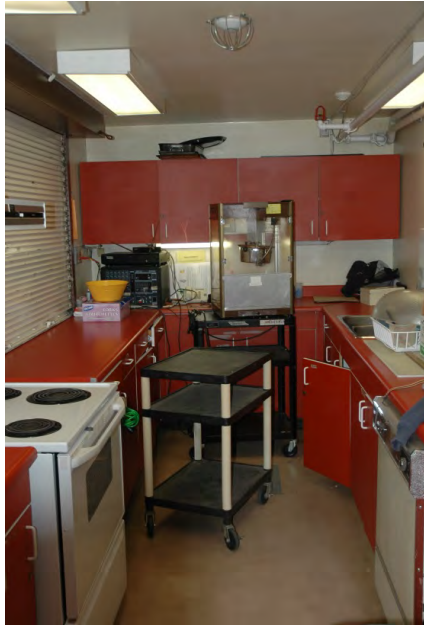
Millwork and fittings in 1998 block are superior to what is found in the rest of the school.

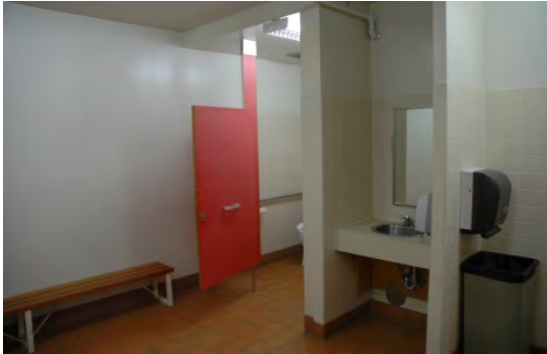
Gym change rooms lack current code requirements for accessibility.

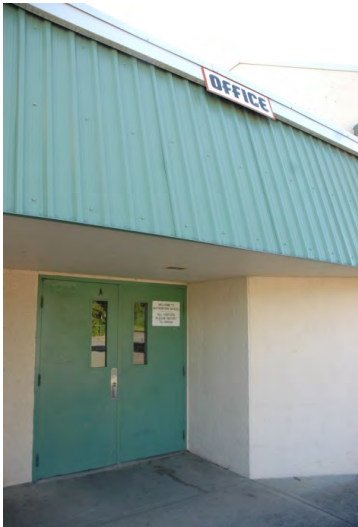
Signage is generally of poor quality and interior signage does not meet code for accessibility to the visually impaired.

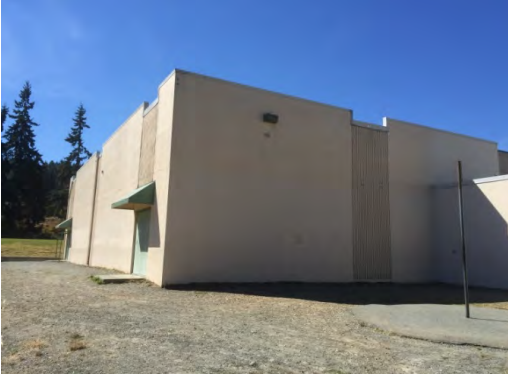
PHOTO A –

The concrete walls of the gymnasium showed no obvious signs of structural cracking.

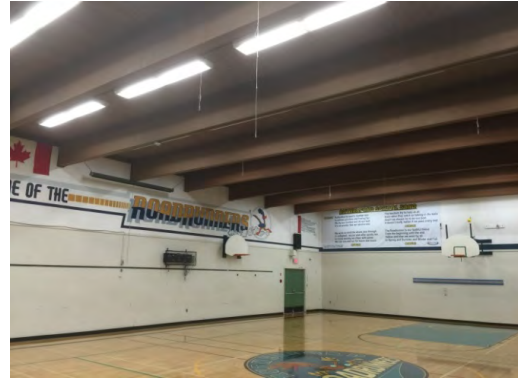
PHOTO B-

The glulam and T&G roof system showed no signs of obvious condition issues.

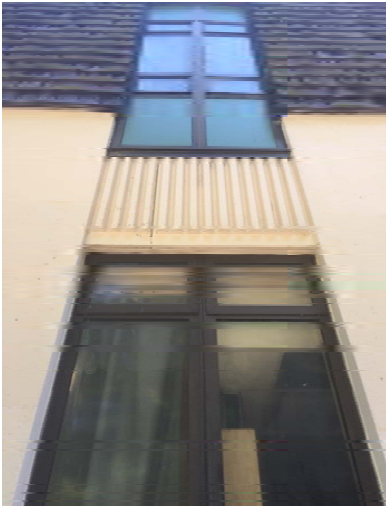
Photo A –

Exterior exposed concrete and cedar finishes did not indicate any obvious structural condition issues.

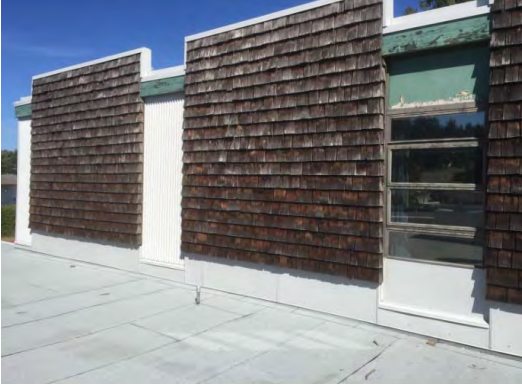
Photo B-  
Sections of roof where Block 2 and 3 abut  
have been re-flashed. No reports of problems  
with framing were identified in these locations.

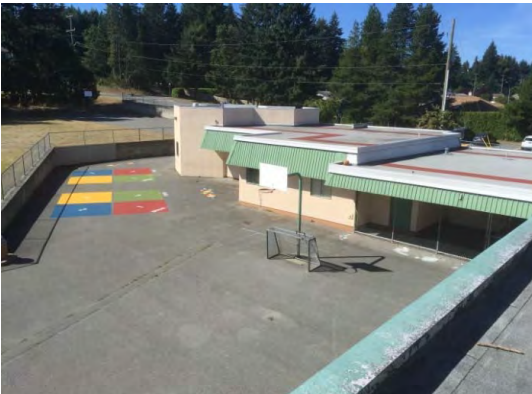
Photo A –  
View to rear of block. Note 1964 section in the  
foreground and 1976 concrete structure in  
the background.

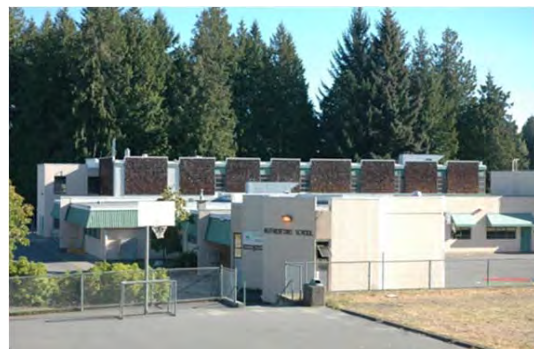
Photo B –  
View looking north towards school showing  
concrete 1976 section of Block 3.

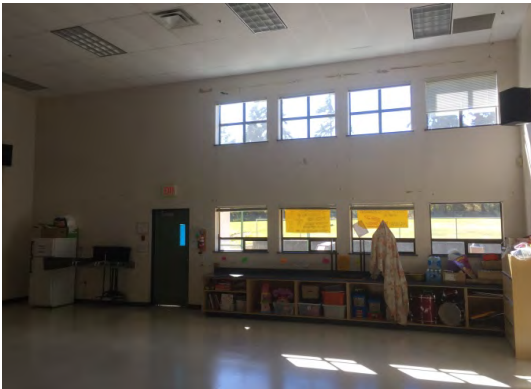
Photo B –  
Interior view of activity room adjacent to  
Gymnasium.

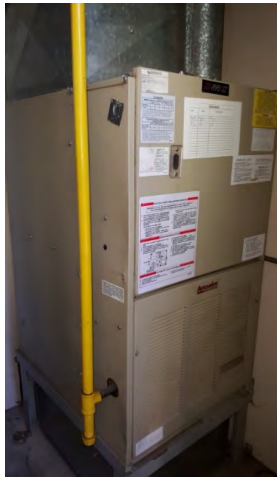
**Condition Rating:** Poor with all systems well beyond their expected useful service life.

Natural gas furnace (typ. of 2)

**Renewal:** Lifecycle replacement to meet current code compliance for improved ventilation.

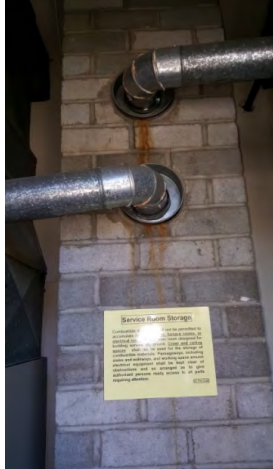
Chimney and existing breeching.  
Recommended to be demolished  
with venting replaced with new.

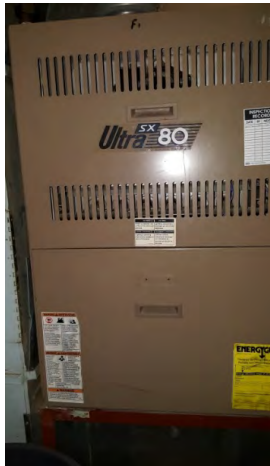
**Condition Rating:** Poor with all systems well beyond their expected useful service life.

Armstrong Ultra SX 80 natural  
gas furnace  
(typ. of 2)

**Renewal:** Lifecycle replacement to meet current code compliance for improved ventilation

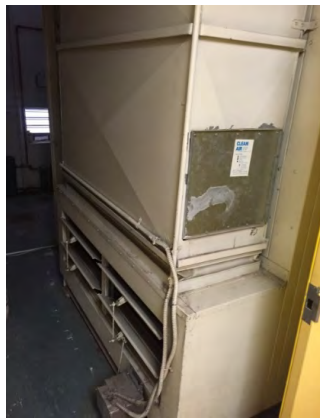
**Condition Rating:** Poor with system well beyond their expected useful service life.

Engineered Air model air handling unit. (rated for 5,700 CFM)

**Renewal:** Lifecycle replacement to meet current code compliance for improved ventilation

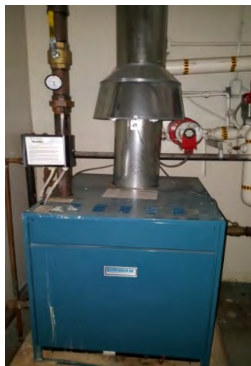
Natural Gas-fired boiler. Replaced 10 years ago.

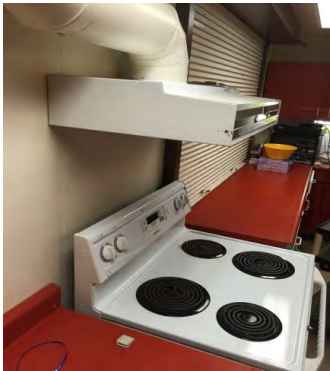
Kitchen range exhaust system. Recommend life cycle replacement

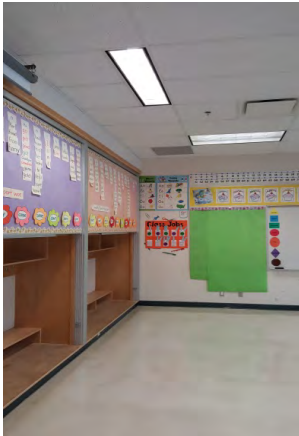
1998 classroom wing classroom ventilation (typical)

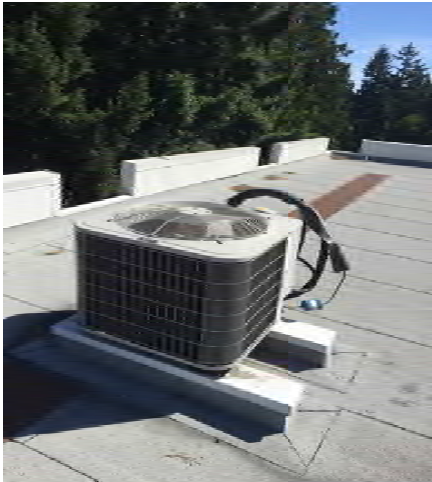
Condensing unit serving the computer lab. Appears in fair condition.

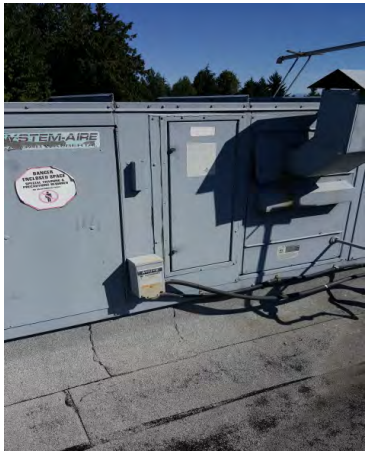
Rooftop gas-fired air handling unit. (typical of 3).

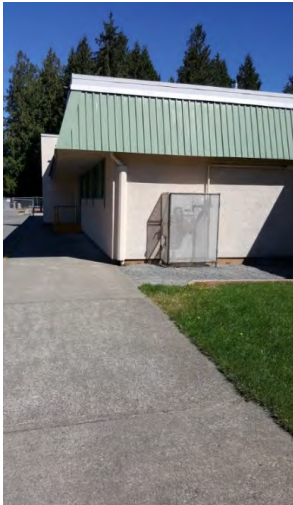
Newer gas meter installed with 1998 addition.

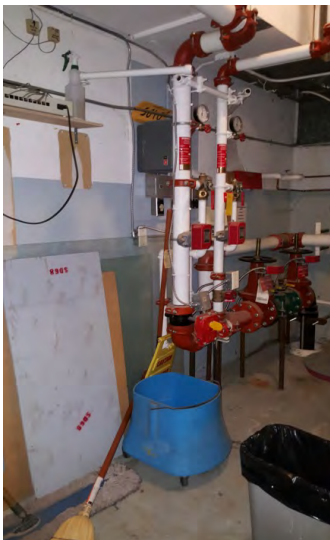
**Condition Rating:** Good

Fire Protection system zone control valves and main distribution header

**Renewal:** Preventative maintenance.

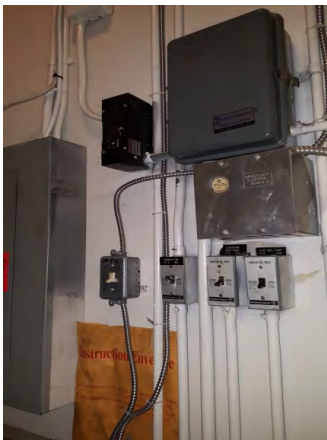
**Condition Rating:** Poor

Fan controls and starters in  
mechanical room

**Renewal:** Lifecycle replacement and preventative maintenance.
